Repair Manual Supplement: Vehicle Pulling to One Side

Service Category Steering

Section Steering Gear/Linkage

TSIB SUPERSESSION NOTICE

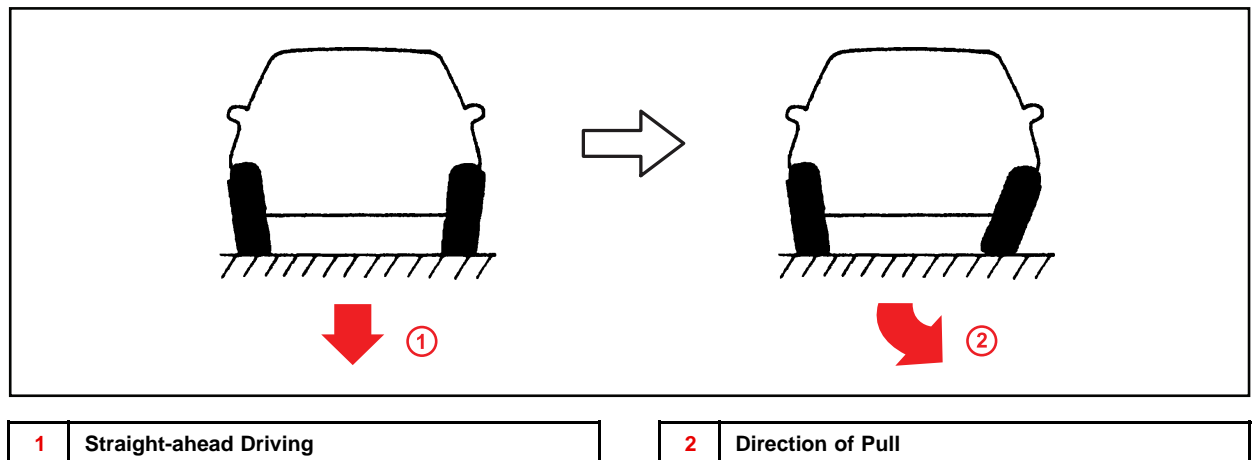
Figure 1. Camber

When the cross camber or caster of the front wheel alignment is large, it can cause vehicle pulling.

WHEEL ALIGNMENT	DIRECTION OF VEHICLE PULLING
Camber	Vehicle Pulls in Direction of Wheel with Large Camber Value (See Figure 1)
Caster	Vehicle Pulls in Direction of Wheel with Small Caster Value (See Figure 2)

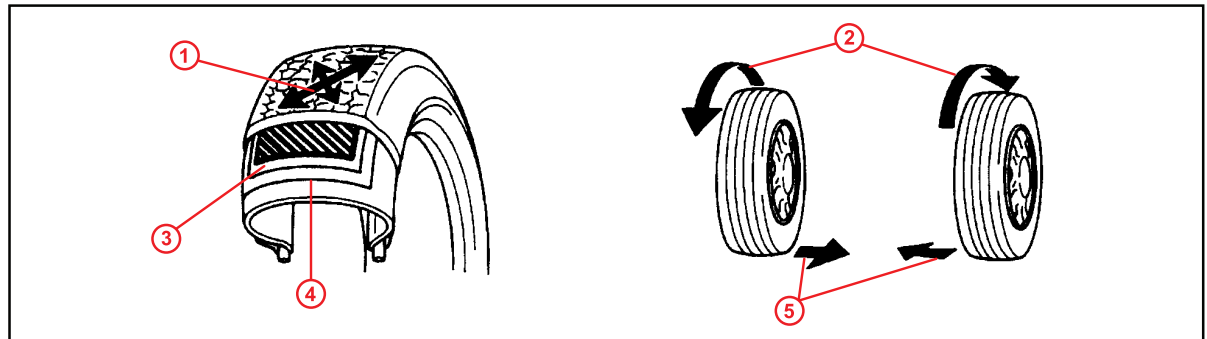
Figure 3.

Lateral force due to ply-steer is produced by the construction of the belts inside the tire tread. With radial tires, the wire of the belt is slanted as shown in the illustration below. Thus, it is in the lateral direction that tire tread easily changes shape (stretches), and lateral force is generated between the tire and the road surface in the lateral direction.

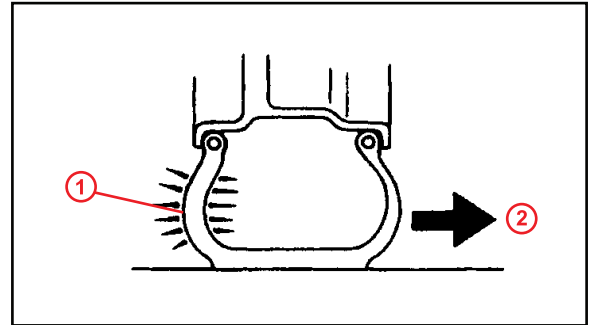
Figure 4.

Conicity is lateral force resulting from uneven formation of the left and right sides of the tire. The direction the lateral force is exerted depends on the hardness of the side walls and the difference in height between the left/right sides of the tire.

- In the case of vehicle pulling caused by tires, the lateral force which is exerted as a result of conicity has the greatest effect. On a flat road, if the steering wheel is held without exerting steering effort for 109 yards (100 m) when traveling at 62 mph (100 km/h), the vehicle may drift as much as 5 feet (1.5 m).
- When vehicle pulling is due to conicity, the amount of drift can be reduced and the direction of drift can be changed by changing the location of the tire or reversing the tire when installing it on the wheel.

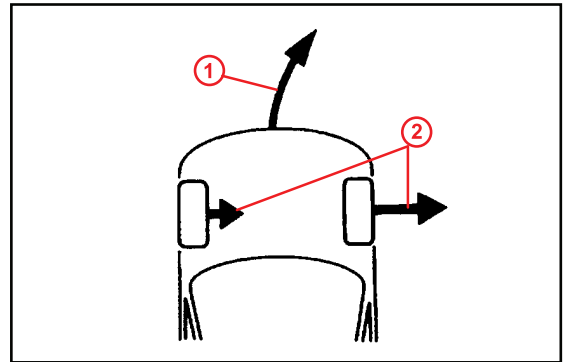
Figure 6. Original Tire Positions

- The vehicle is pulled to the right by the lateral force exerted to the right.

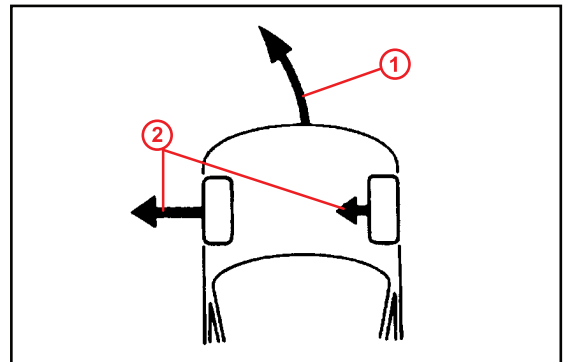
Figure 7. Tires Switched

- The direction of the tires which exerted lateral force to the right has been changed, so the tires now exert lateral force to the left and the vehicle now pulls to the left.

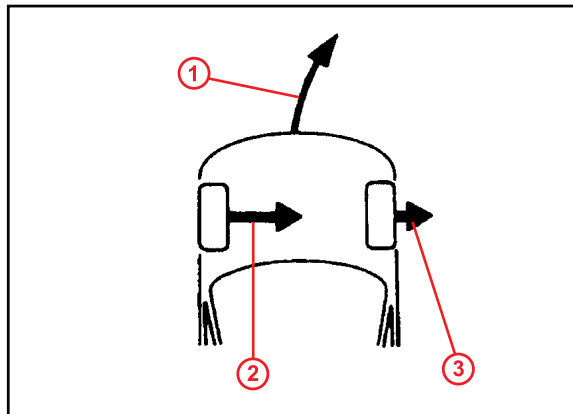
Figure 11. Original Tire Positions

The lateral force generated by the left front tire is greater than the right tire, so the vehicle is pulling due to the lateral force of the left tire.

- B. Rotate the **larger** lateral force front tire with the rear tire and check the change in the vehicle pulling.

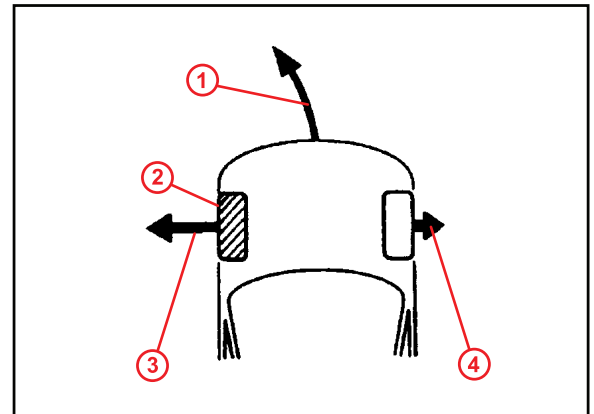
Figure 12. Left Tire Reverse Installation

If Vehicle Pulls in the Opposite Direction: Go to step 3B.
