**Introduction** This bulletin contains general vehicle pulling diagnosis and repair procedures along with specific information to help correct pulling complaints.

**Applicable Vehicles**

- **2002 – 2006** model year **Toyota** vehicles.
- **2004 – 2006** model year **Scion** vehicles.

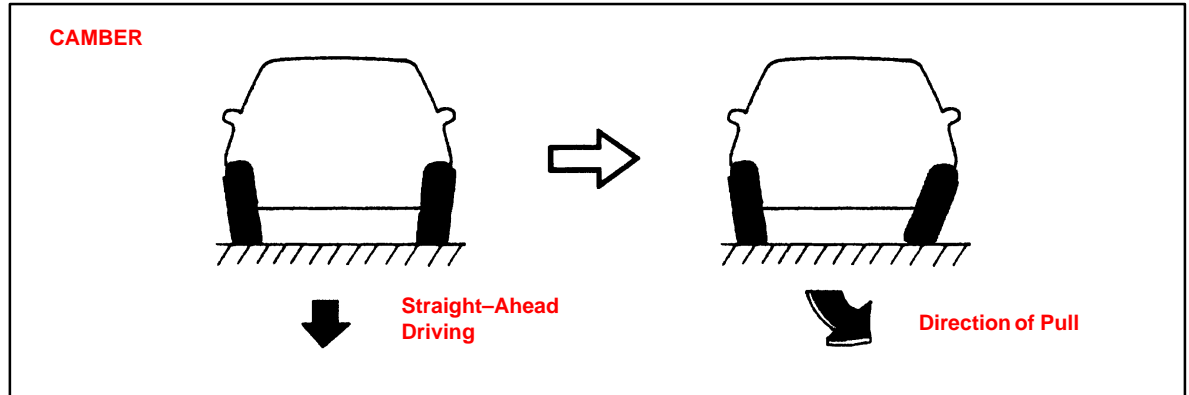
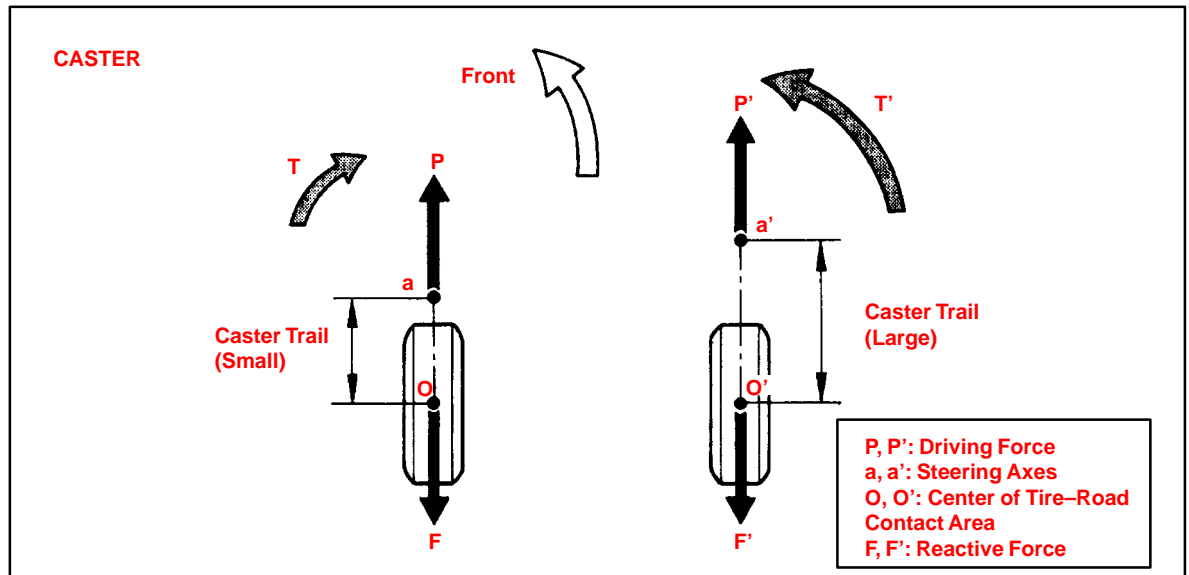
**1. Relationship Between Wheel Alignment and Vehicle Pulling to One Side**

When the cross camber or caster of the front wheel alignment is large, it can cause vehicle pulling.

WHEEL ALIGNMENT	DIRECTION OF VEHICLE PULLING
Camber	Vehicle pulls in direction of wheel with large camber value
Caster	Vehicle pulls in direction of wheel with small caster value

If the cross camber or caster is within the specified range (30' or less), noticeable vehicle pulling will not occur due to side-to-side differences in camber or caster.

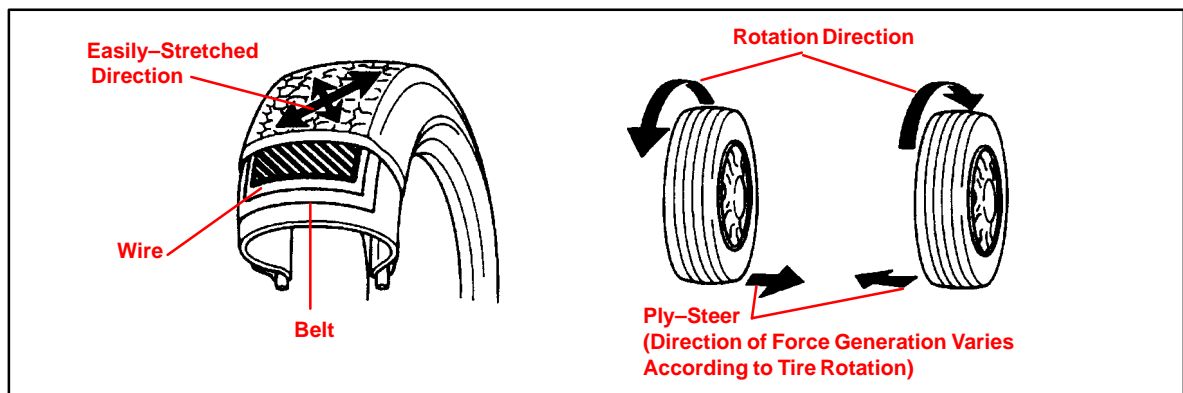
### A. Ply–Steer

Lateral force due to ply–steer is produced by the construction of the belts inside the tire tread. With radial tires, the wire of the belt is slanted as shown in the illustration below. Thus, it is in the lateral direction that tire tread easily changes shape (stretches), and lateral force is generated between the tire and the road surface in the lateral direction.

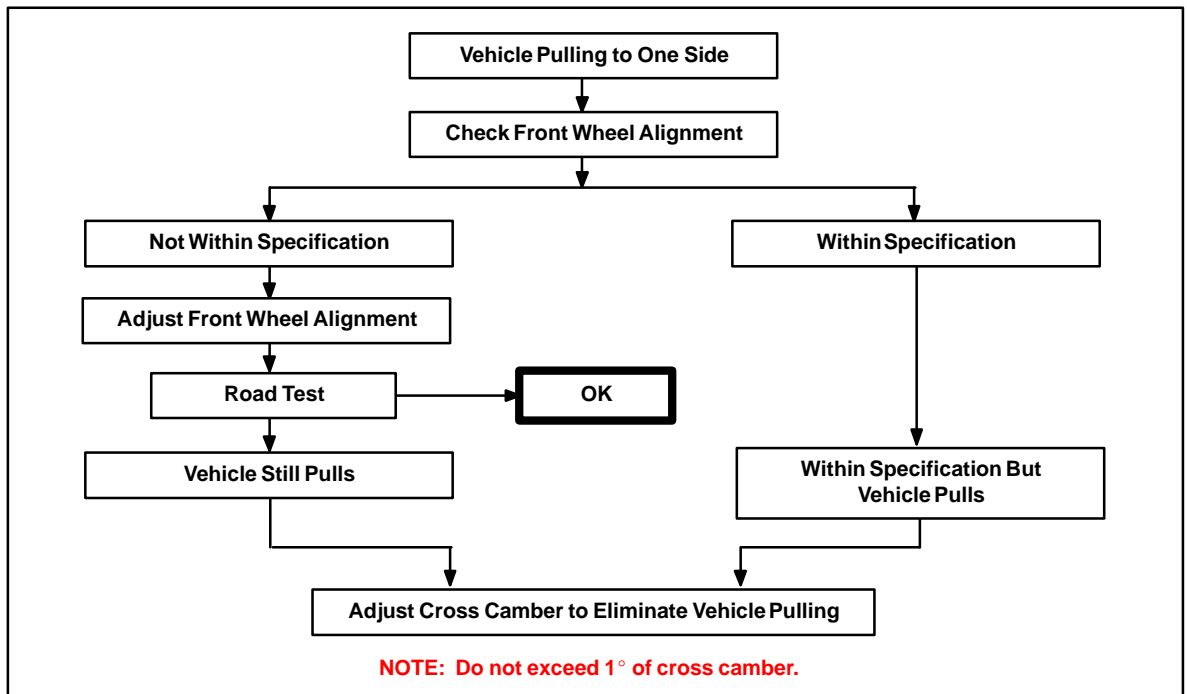
**3. Vehicle Pulling Caused by Wheel Alignment**

When it is determined by troubleshooting that the vehicle pulling to one side is caused by wheel alignment, perform repairs according to the following procedure.

WHEN VEHICLE PULLS TO LEFT	WHEN VEHICLE PULLS TO RIGHT
Increase right front camber and decrease left front camber until vehicle pulling is eliminated	Increase left front camber and decrease right front camber until vehicle pulling is eliminated

- Keep the cross camber within 1° or less.
- Keep the camber of each wheel within specifications (+/-45' of center value).
- If adjustment exceeds the specifications, uneven tire wear will result.
