Air Injection Pump With Water Intrusion: MIL "ON" DTC P0418, P0419, and/or P244#

Service Category Engine/Hybrid System

YEAR(S)	MODEL(S)	ADDITIONAL INFORMATION
2008	Sequoia	
2007 – 2008	Tundra

TSB REVISION NOTICE

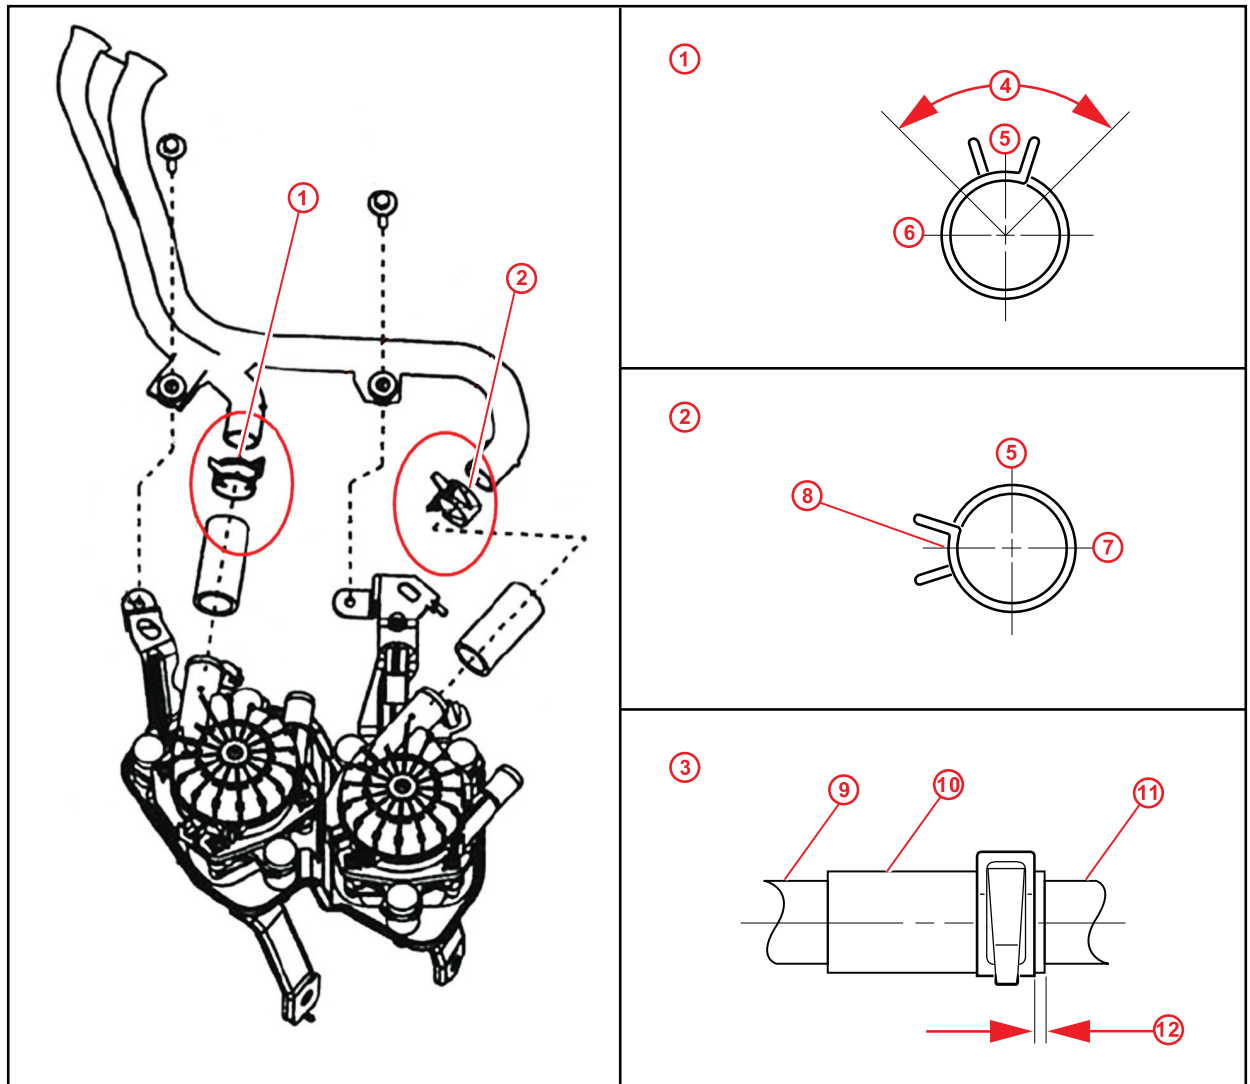
Figure 1. 1GR-FE/3UR-FE Air Injection Pump Assembly (with clamps)

Some 2007 – 2008 model year Tundra and 2008 model year Sequoia vehicles may exhibit a MIL "ON" condition with Diagnostic Trouble Codes (DTCs) P0418, P0419, P2440, P2441, P2442, P2443, P2440, P2441, P2442, P2443, P2445, and/or P2447. This concern may be caused by water intrusion into the air injection pump assemblies. Use the following procedure to address this condition.

- *Engine/Hybrid System – Emission Control – [“3UR-FE / 2UZ-FE Emission Control: Air Pump: Removal”](#)*
4. With the pumps removed from the vehicle, verify if there is liquid or evidence that liquid entered the pumps.
 - **YES** — If there is liquid evidence, go to step 5.
 - **NO** — If there is NO evidence of liquid, go to step 7.
 5. If liquid evidence is present, replace the two pump assemblies and install clamps on the inlet pipe to air pump hose joint as shown below in Figures 1 and 2.

Make sure the clamp orientation is as shown in Figures 1 and 2.

1	Clamp 1 Installation Orientation
2	Clamp 2 Installation Orientation
3	Clamp Installation Location (Typical)
4	90°
5	Upper
6	RH

7	LH
8	Hose Stopper Must Remain Within Clip Tabs
9	Air Pump
10	Air Hose
11	Inlet
12	Approximately 0 – 5 mm (0 – 0.2 in.)
