# SERVICE BULLETIN

Classification: EC05-009	Reference: NTB05-067	Date: October 5, 2005
-----------------------------	-------------------------	--------------------------

## PROCEDURE TO COMPLETE IAVL WHEN IDLE SPEED NEEDS TO BE REDUCED.

**APPLIED VEHICLES:** All 2002 – 2005 models

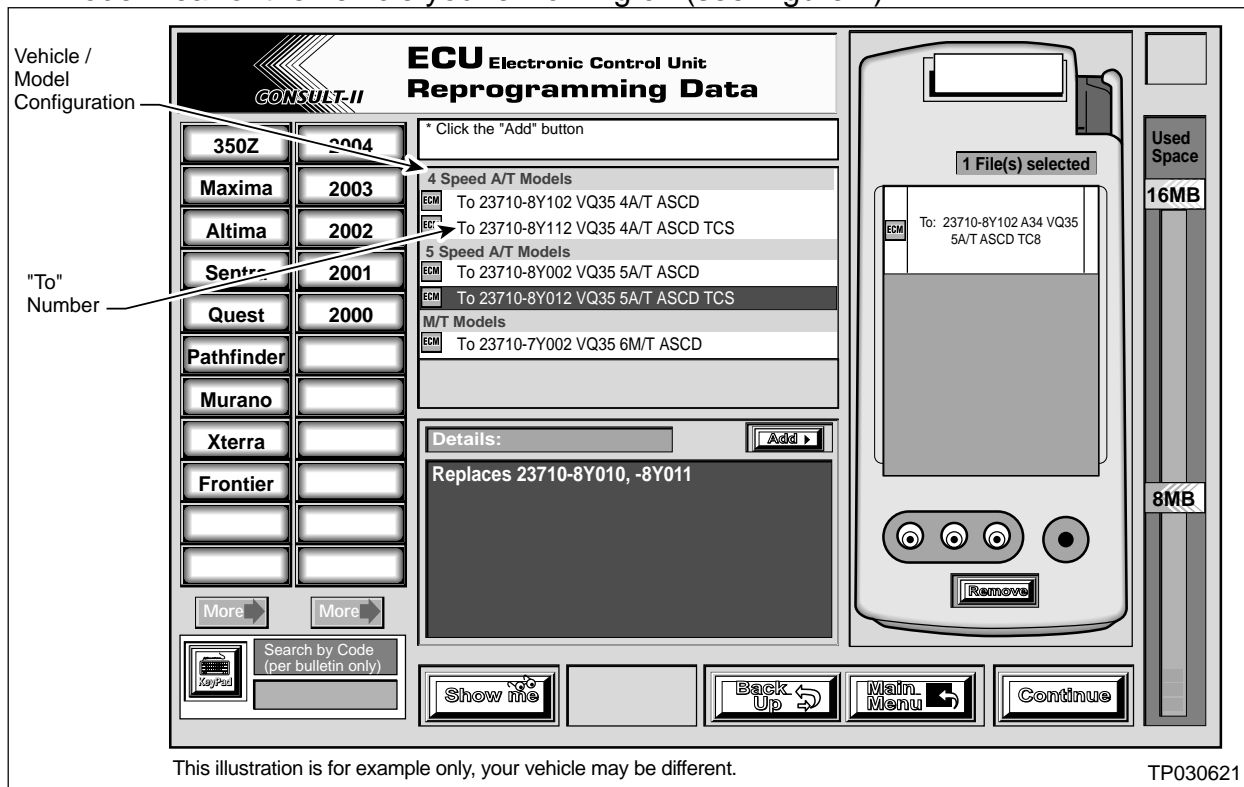
Figure 1

B. Go to ASIST: Select CONSULT Utilities > ECM/TCM Data. Then choose Model and Model Year of the vehicle you’re working on (see Figure 1).

C. Select the “configuration” on the screen for the vehicle you’re working on. Then **make sure** that your current ECM P/N is listed in the “Replaces 23710-XXXXX, -XXXXX, etc” section in the lower, center “Details” panel of the ASIST screen (see Figure 1).
