EG-00037T-TME

Technical Service Bulletin

1NR Engine: Hard to start

Auris - NRE180; Corolla - NRE180; Yaris - NSP130; Verso-S - NSP120

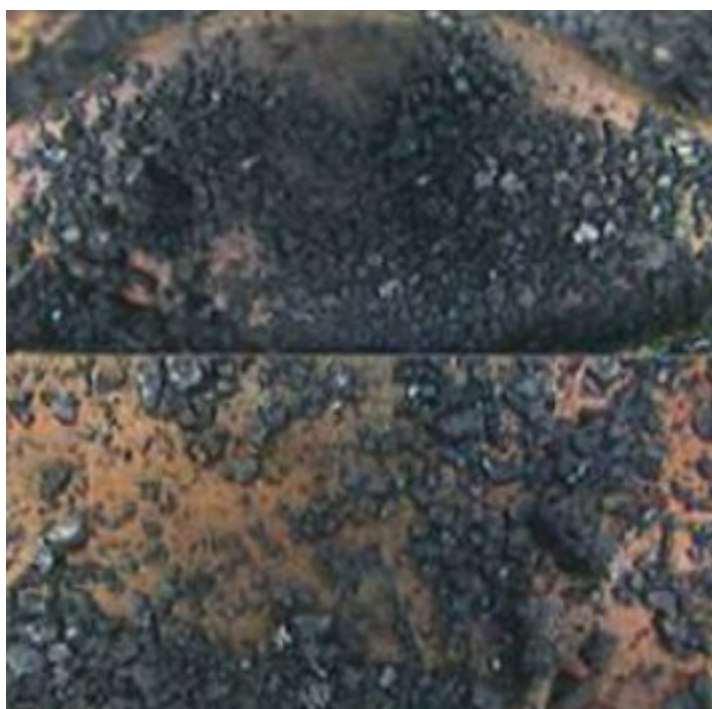
Many different factors can affect engine start-ability, but the scope of this bulletin is exclusively for cases where root cause is high concentration of carbon deposits.

Example of carbon deposits on piston surface.

1) REPLACE STARTER AND BATTERY AS INDICATED BELOW:

1. **DISCONNECT AND REMOVE THE BATTERY (ONLY FOR APPLICABLE YARIS).**
2. **REMOVE THE STARTER AS INDICATED IN THE REPAIR MANUAL.**
3. **INSTALL THE NEW STARTER AS INDICATED IN THE REPAIR MANUAL.**
4. **WHEN APPLICABLE, REPLACE BATTERY TRAY (ONLY FOR APPLICABLE YARIS).**
5. **INSTALL THE BATTERY (ONLY FOR APPLICABLE YARIS).**
6. **CONTINUE TO REPROGRAMMING PROCEDURE.**

Reprogram the "Computer, Engine Control" to the latest available calibration ID (minimum to the new CID as shown in below table) and apply a new ECU label sticker (part number: 89685-20010) with the correct ECU part number.

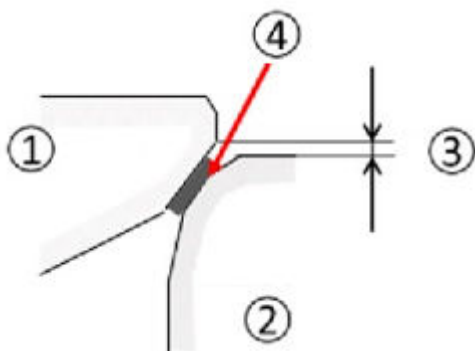
Carbon deposits are not abnormal inside combustion chamber, but some of the existing fuel additives in the market can affect deposits concentration in terms of amount and size. Once those deposits flow through the exhaust valves, the biggest ones could remain between the valve and the valve seat creating a gap. This gap causes lack of compression and consequently, difficulties to start the engine.

Example of how deposits could cause lack of compression.

(1=Valve; 2=Valve seat; 3=Gap caused by deposit; 4=Carbon deposit)
