Subject		Market
Abnormal 1-2 and/or 2-3 Shift after Transaxle Replacement or Engine Repair		USA
Service Category	Section	
Drivetrain	Automatic Transmission/Transaxle	
Applicability		
1999-2003 RX300

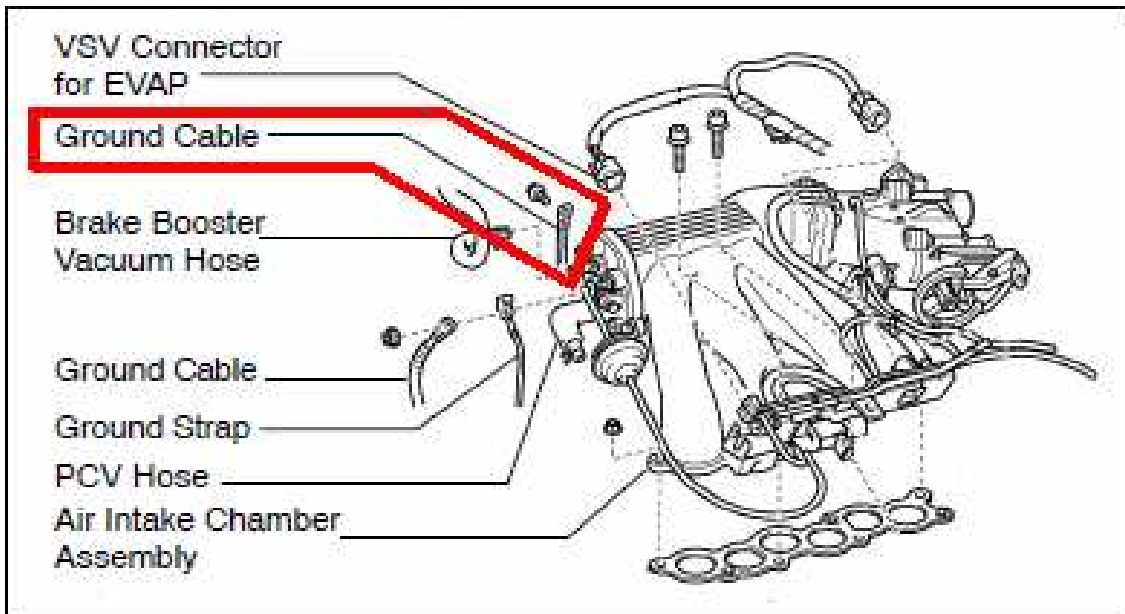
- Customer states the transaxle is not shifting correctly after transaxle/engine repair.
- The 1-2 and/or 2-3 shifts are slipping or shuddering.

- Confirm the EC Ground is correctly fastened to the rear side of the air intake chamber assembly as shown below.
- If the EC Ground was incorrectly fastened to the valve cover or left loose, these shifting concerns will occur.
