**Abnormal 1-2 and/or 2-3 Shift after Transaxle Replacement or Engine Repair**

2001-2003 Highlander & 2002-2003 Camry

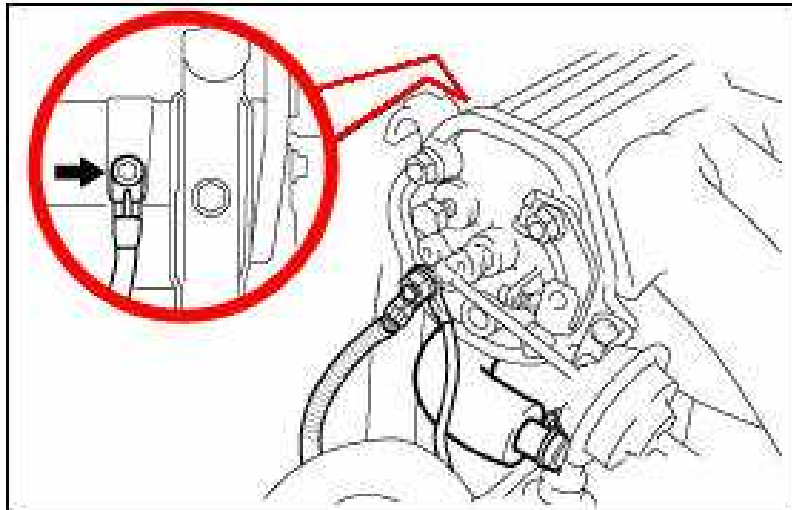
- Customer states the transaxle is not shifting correctly after transaxle/engine repair.
- The 1-2 and/or 2-3 shifts are slipping or shuddering.

- Confirm the ground cable is correctly fastened to the rear side of the intake air surge tank assembly as shown below.
  - The suspect ground cable is referred to as “EC” in the Highlander Electrical Wiring Diagram (EWD) and as “EE” in the Camry EWD.
- If the ground cable was incorrectly fastened to the valve cover or left loose, these shifting concerns will occur.
