Service Category Engine/Hybrid System

Section
 Engine Control
 Market
 USA
 Toyota Supports

Some 2010 model year Corolla and Matrix vehicles may exhibit a MIL "ON" condition with one or more of the following Diagnostic Trouble Codes (DTCs):

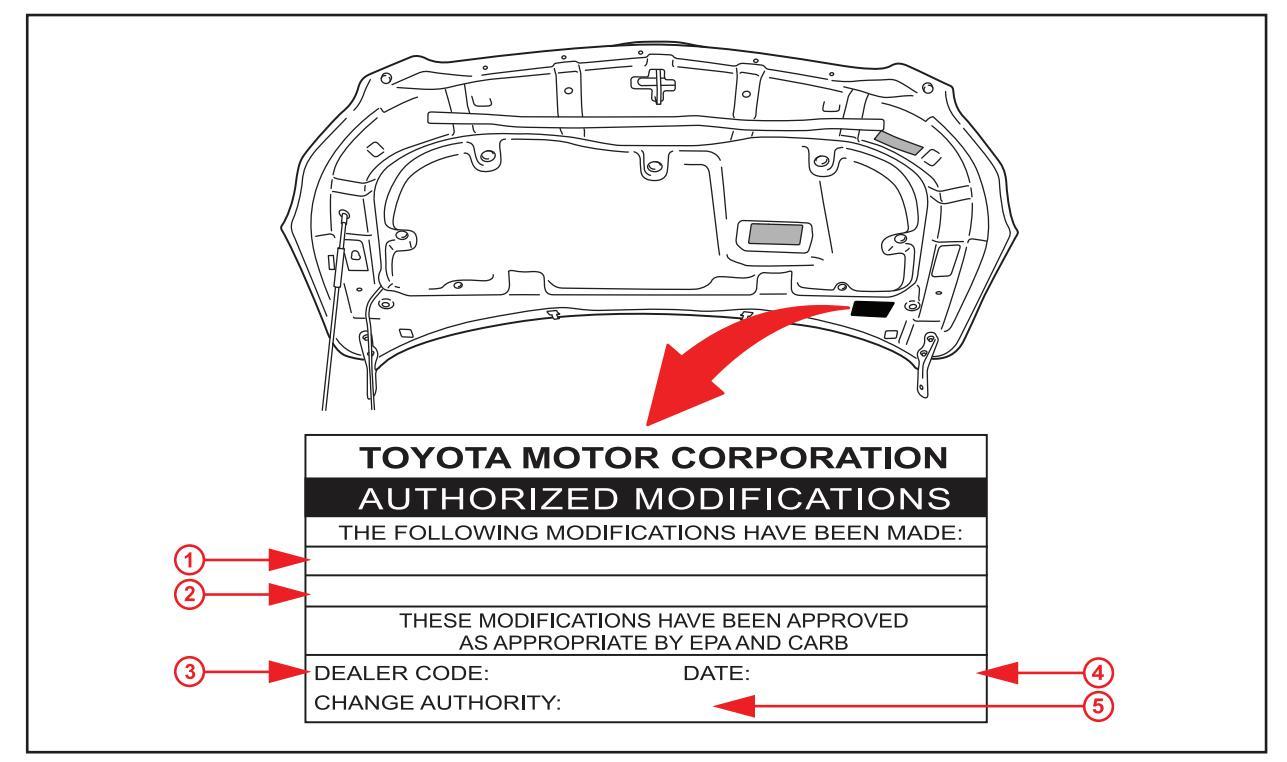
Figure 1. Location of Authorized Modifications Label on 2010 Corolla and Matrix

- YES Proceed to step 2.
- NO This TSB does NOT apply. Refer to the Repair Manual for further diagnosis.
- 2. Replace the A/F sensor and proceed to step 3.
- 3. Check for the Authorized Modifications Label affixed to the vehicle in the location shown in Figure 1. Confirm if the ECM (PCM) calibration has been updated. If the calibration ID listed is NOT the latest ECM (PCM) calibration — go to step 4.

5. Install the Authorized Modifications Label.

A. Using a permanent marker, enter the following information on the label:

- ECM part number [Refer to the **Parts Information** section for the **CURRENT PART NUMBER**]
- Calibration ID(s) [Refer to the Calibration Identification Chart for the NEW CALIBRATION ID]
- Dealer Code
- Repair Date
- Change Authority [This TSB number]
- B. Affix the Authorized Modifications Label to the vehicle at the location shown in Figure 1. The Authorized Modifications Label is available through the MDC, P/N 00451-00001-LBL.
- 6. Test drive the vehicle to confirm proper vehicle operation.
