Active Test "Control the VVT System (Bank 1)" Data List Comparison

Note. Test Description	<ul style="list-style-type: none"> • Engine stalls or idles roughly when camshaft timing oil control valve assembly turned on • Normal engine running or idling when camshaft timing oil control valve assembly off • Test possible while vehicle stopped and engine idling 			
1NZ-FE Data List of Corolla BR-Prod 2009 MY, NZE141R- (U340E)	NORMAL CONDITION ¹ *1	1NZ-FE Data Fielder 2008MY, NZE141G-AWXNK (CVT K31#)

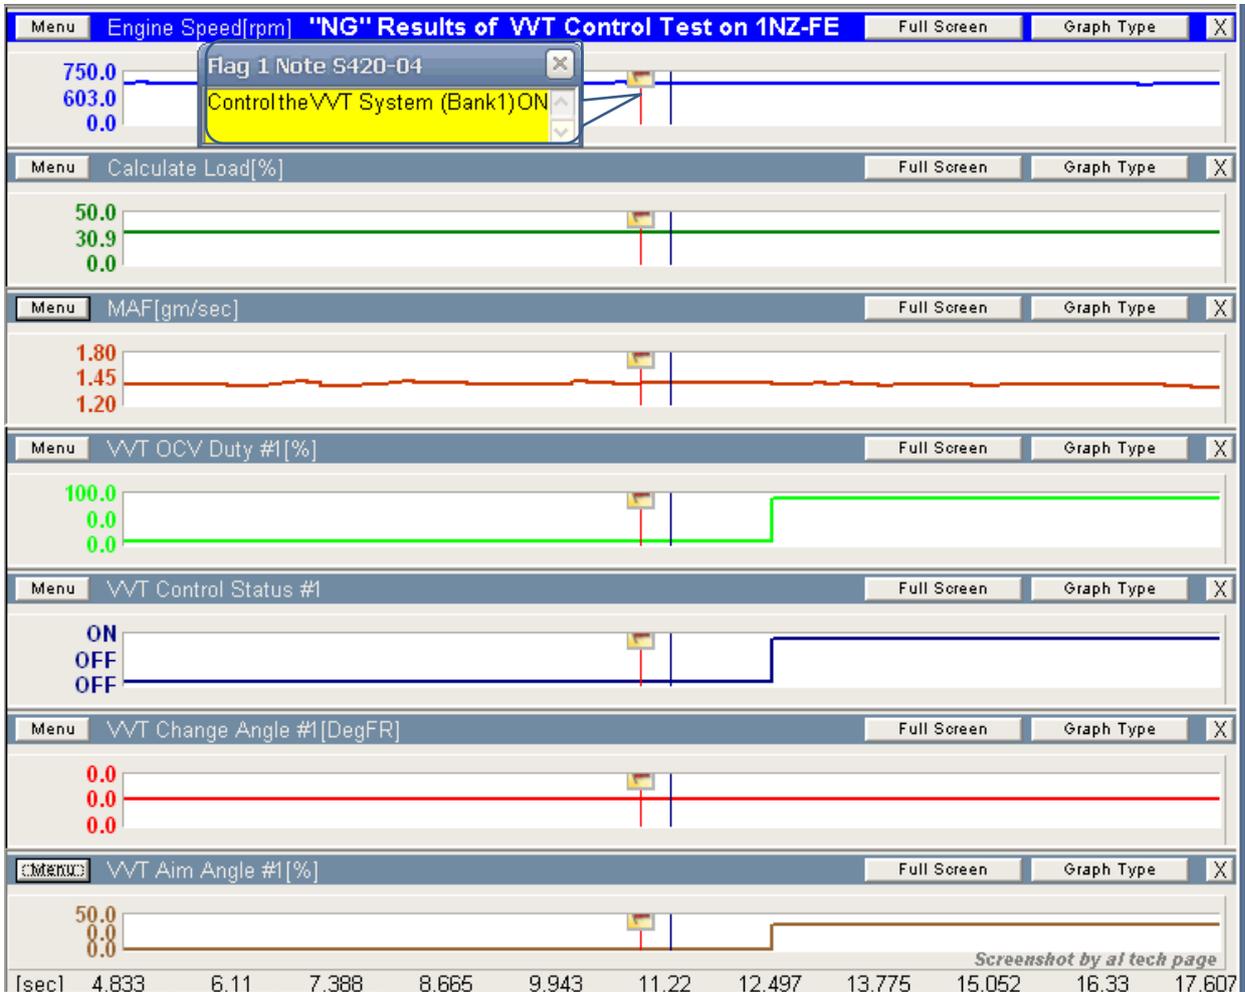
Active Test "NG"

² Possible OCV Filter clogged , insufficient pressure in VVT-I System , etc.

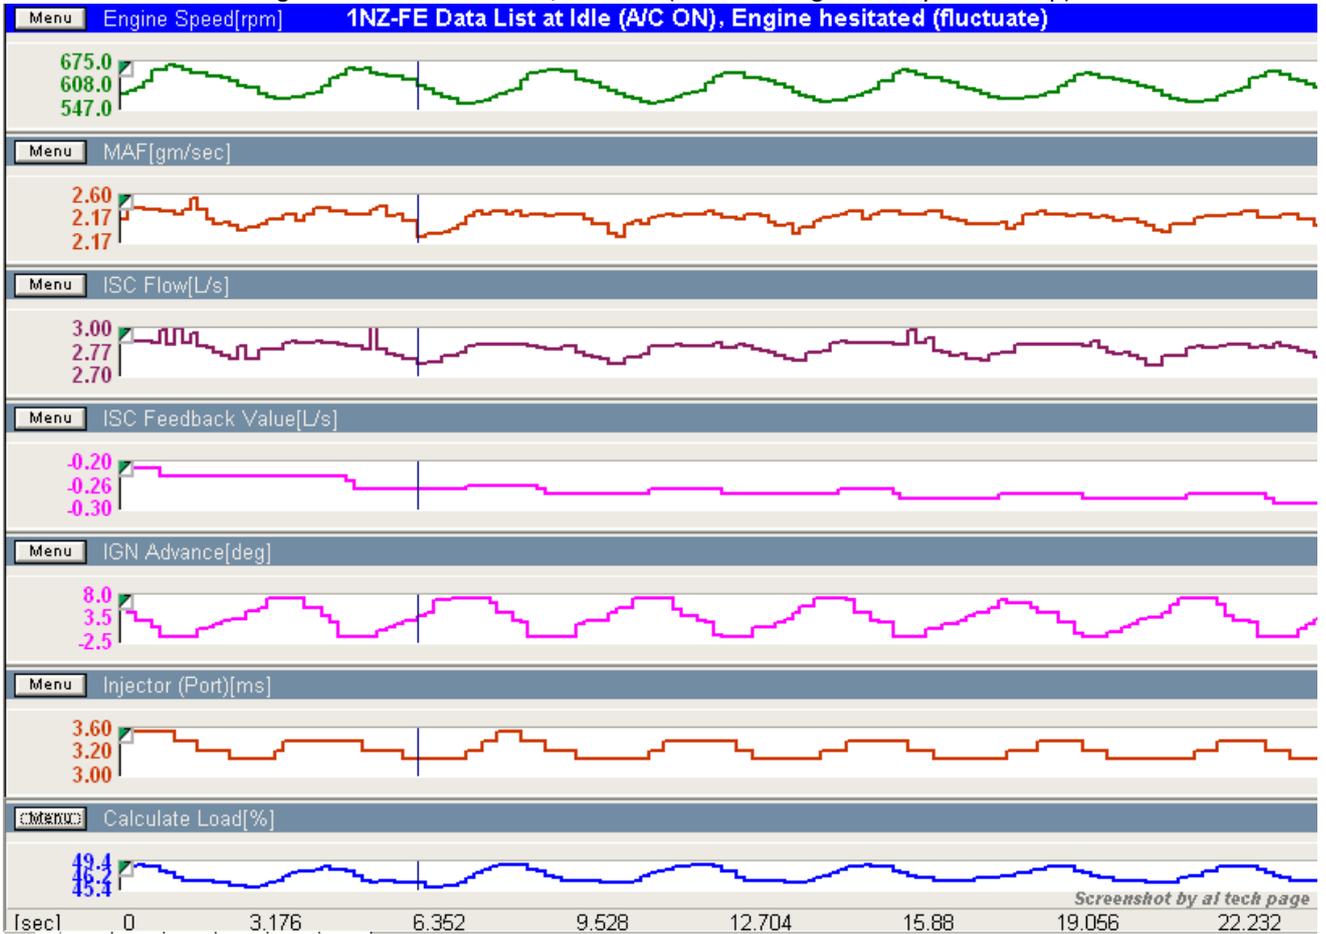
Engine Idle RPMs hesitation/fluctuate (when the engine is fully warmed up)

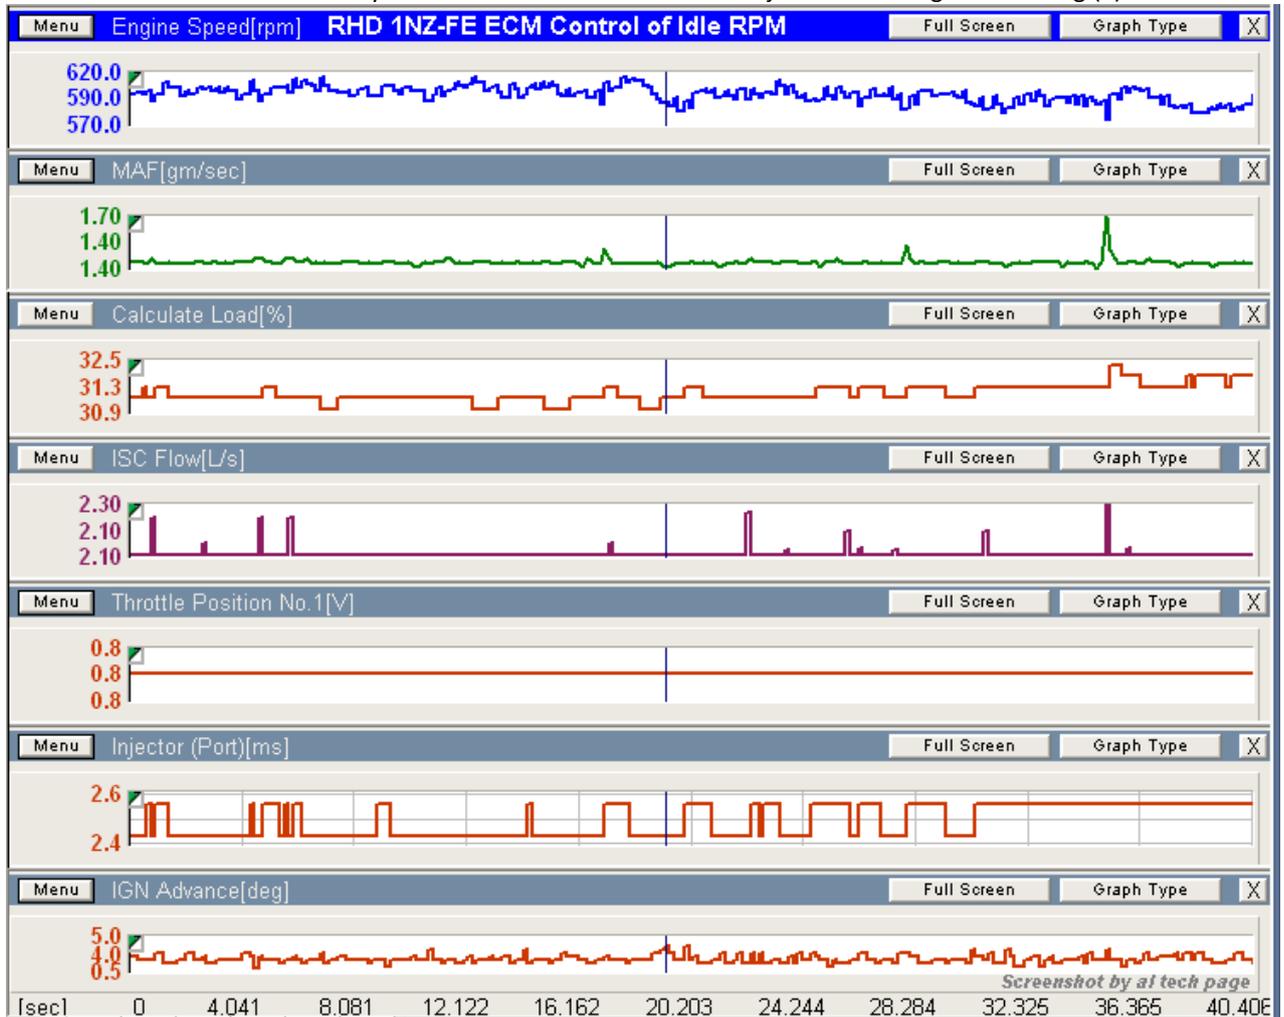
Idle RPM Control by variations of Pulse Width of Fuel Injection and of Ignition Timing (1)

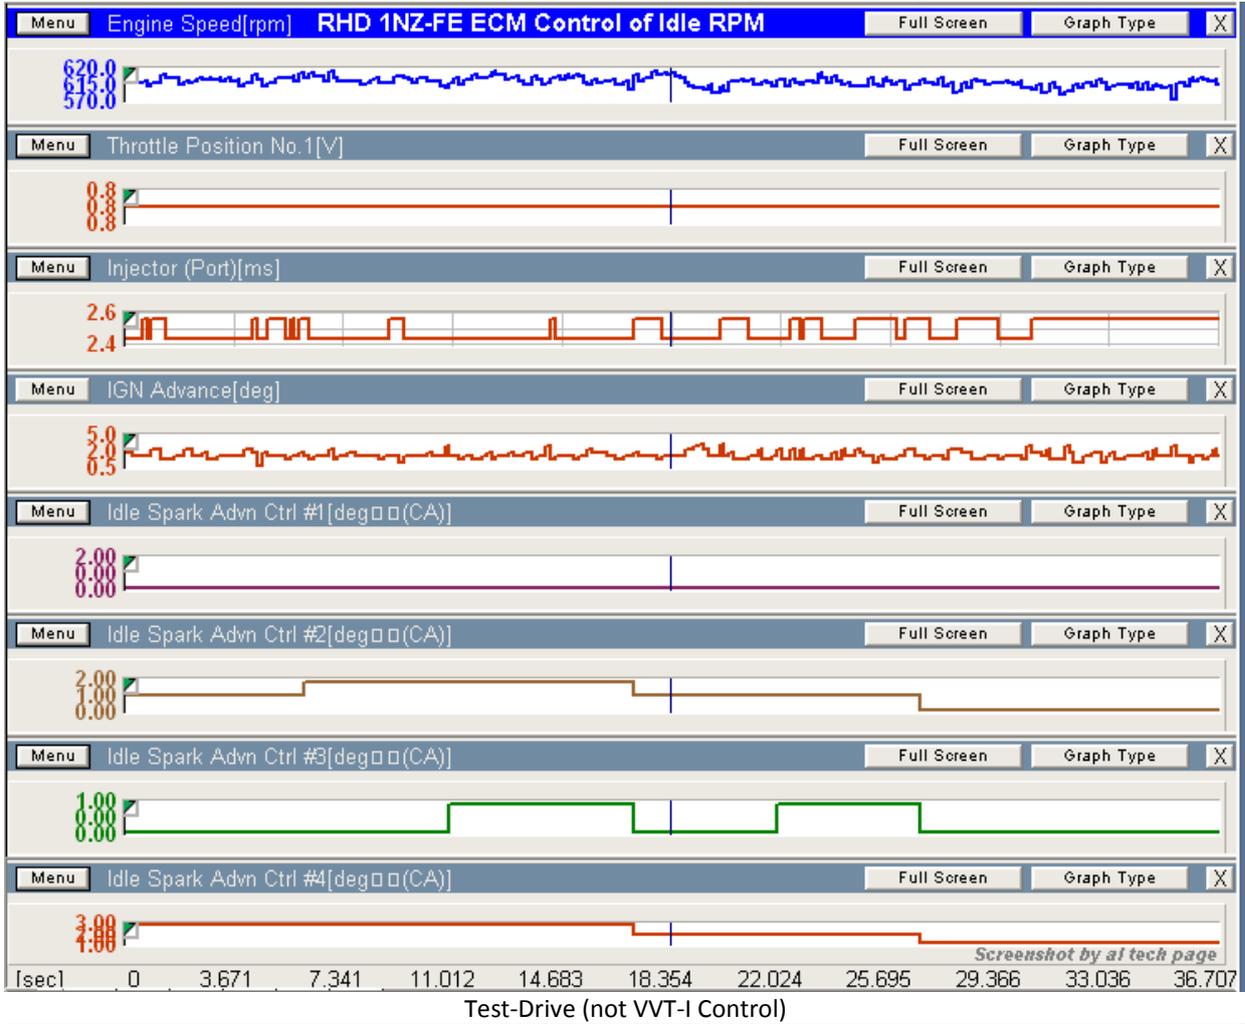
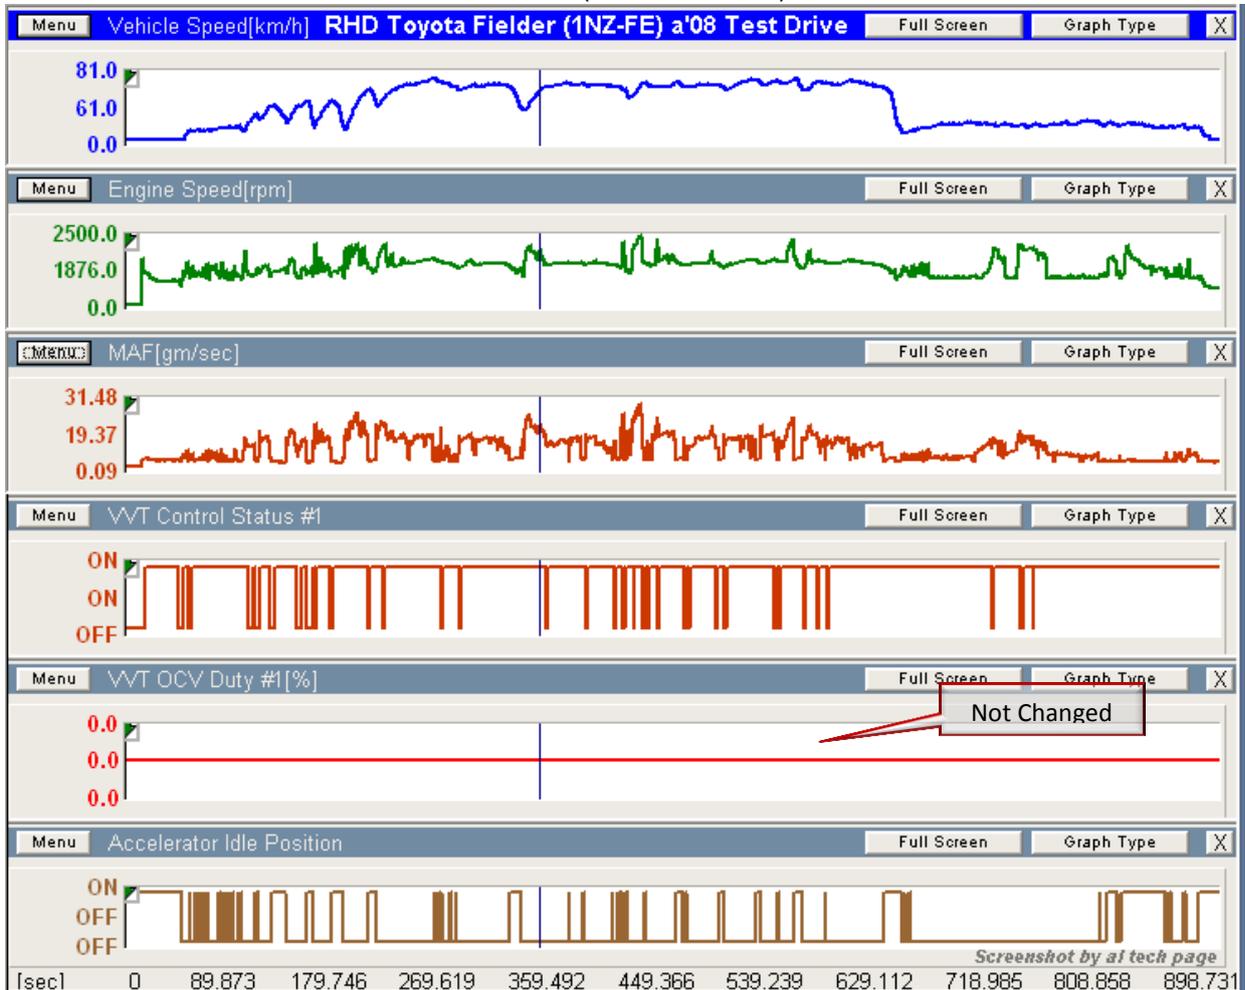
Idle RPM Control by variations of Pulse Width of Fuel Injection and of Ignition Timing (2)

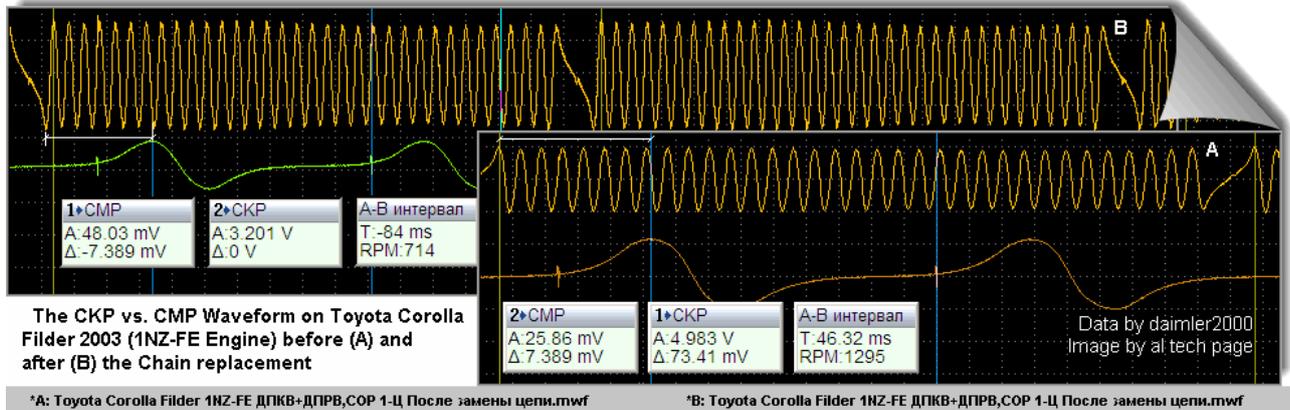
1NZ_FE CKP vs. CMP waveform by PC-based Oscilloscope:

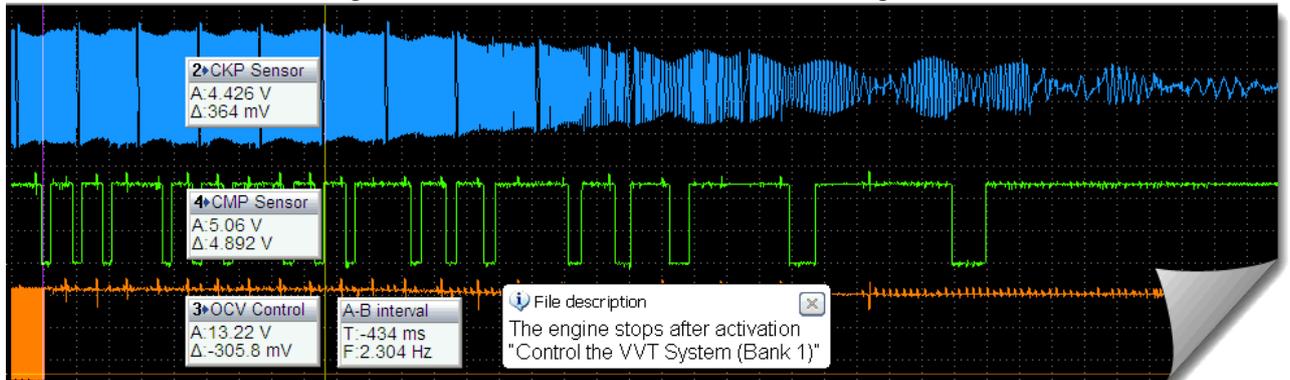
Engine Shutdown after "VVT-I Control" Active Test go to ON:

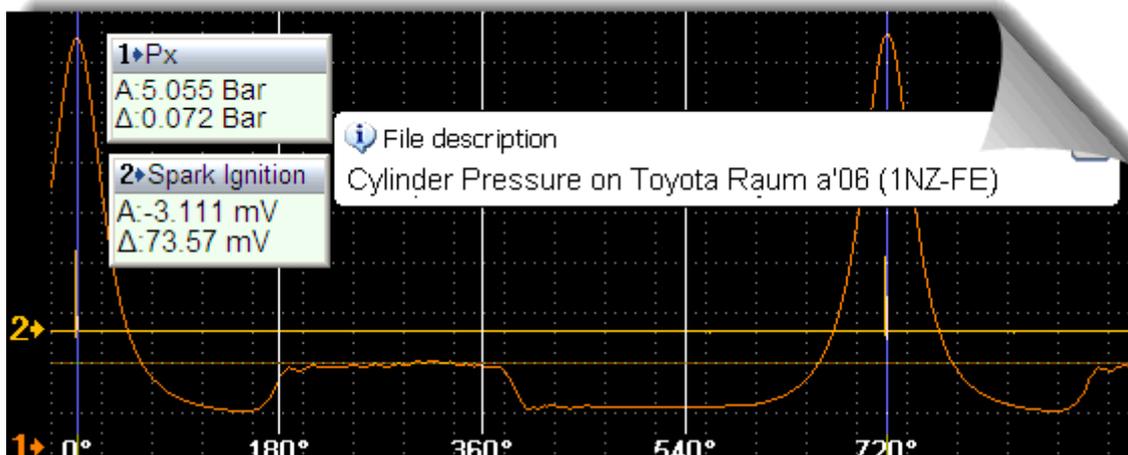
1NZ-FE Cylinder Pressure on Raum 2006MY:

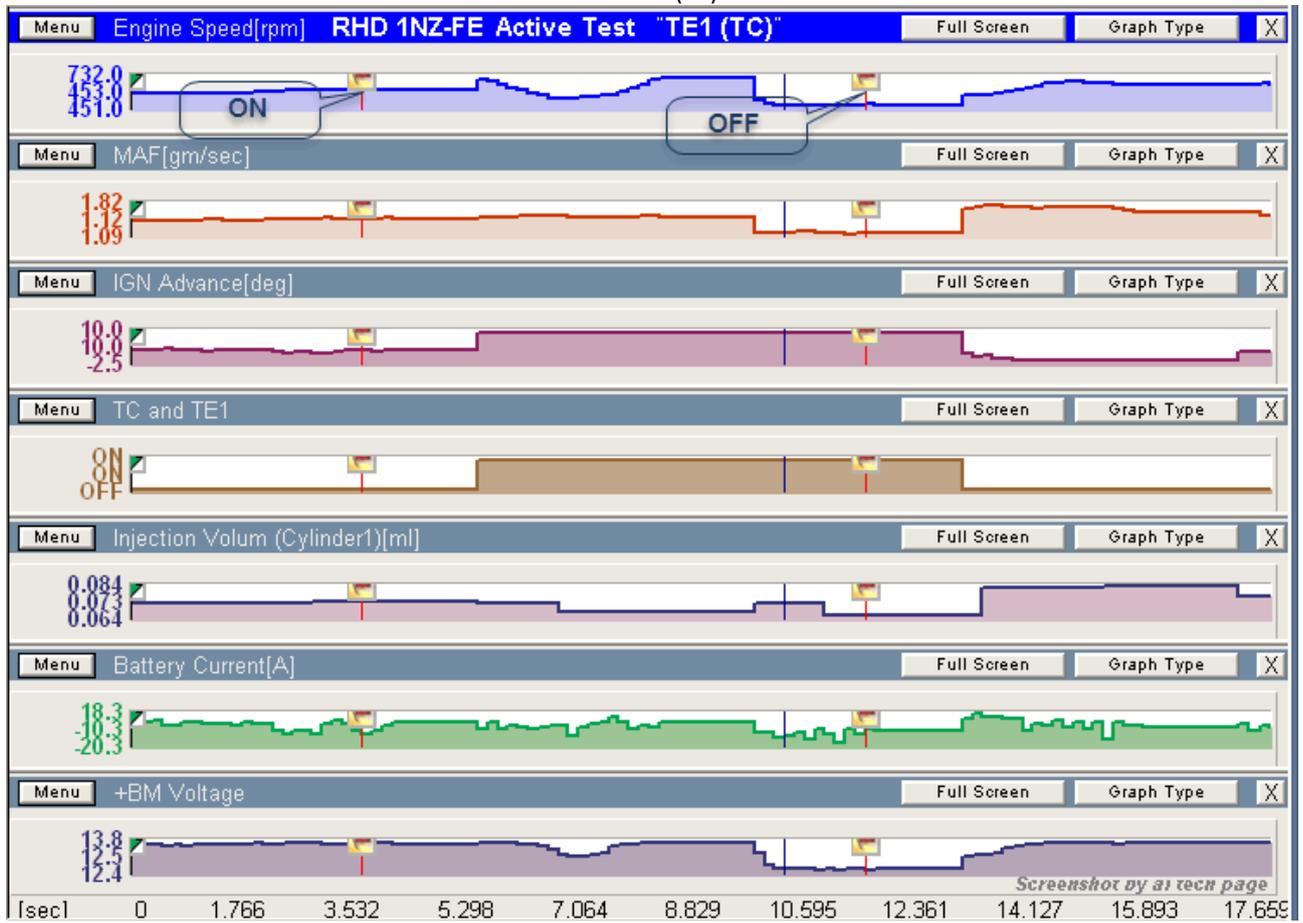
Data Stream at "TE1(TC)" active test

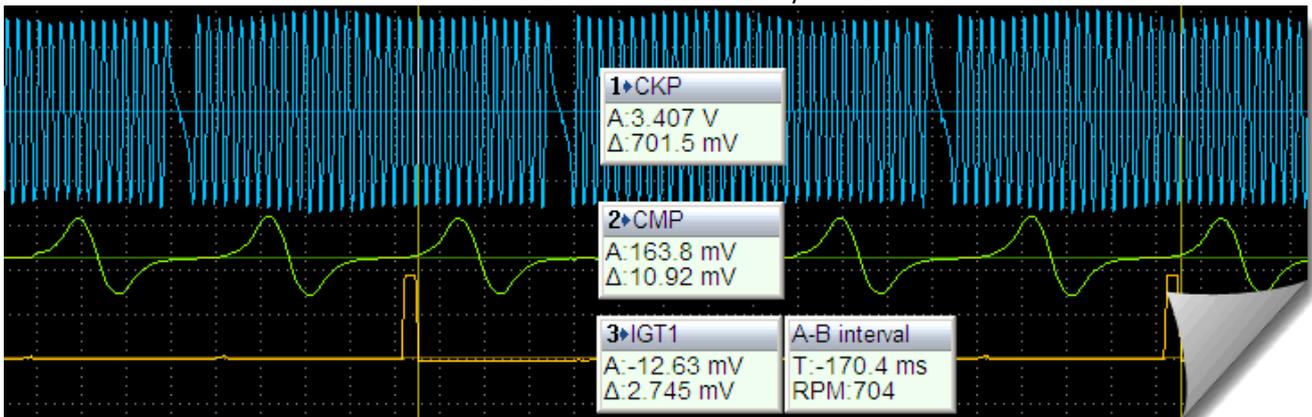
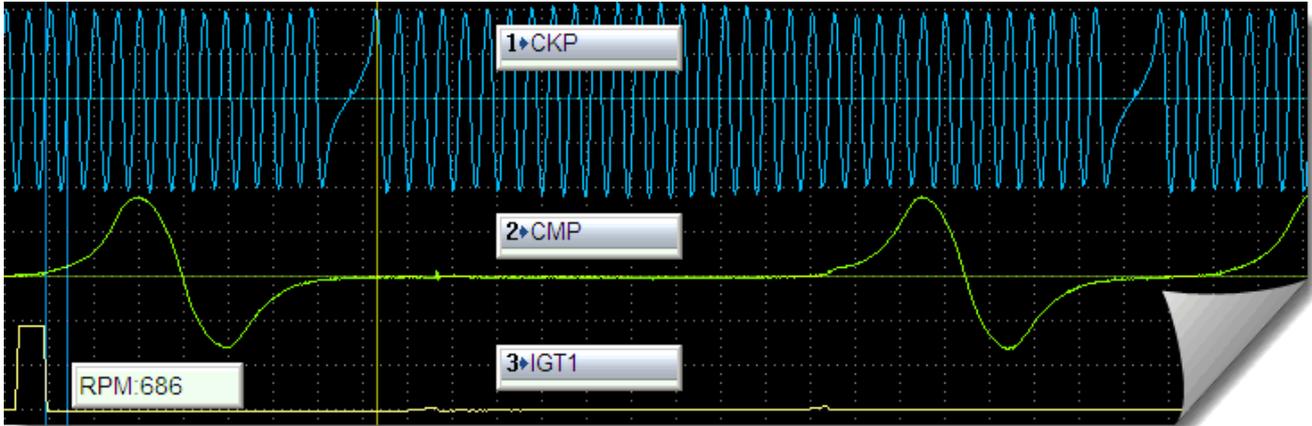
CKP vs. CMP Waveforms of 1NZ-FE Toyota Raum a'06

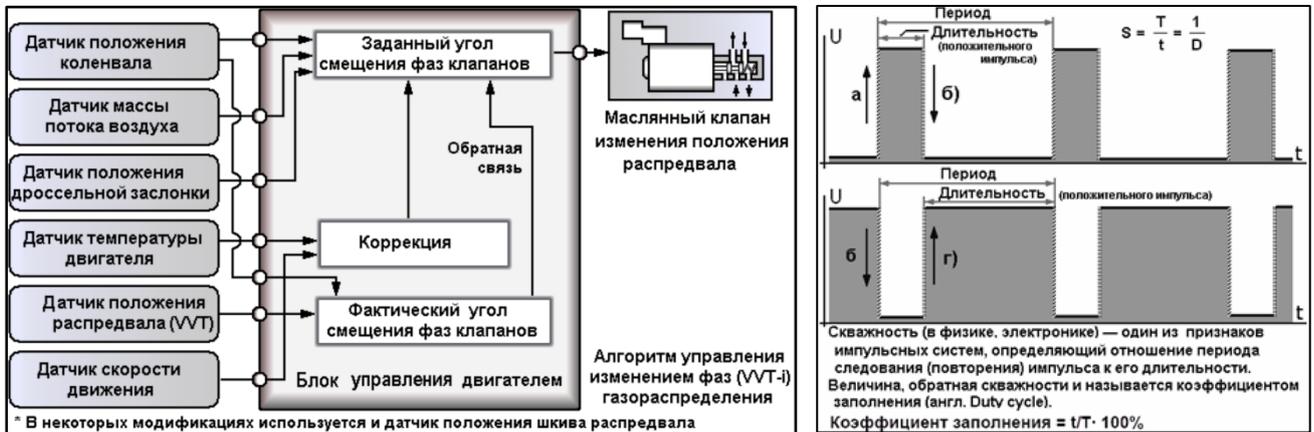
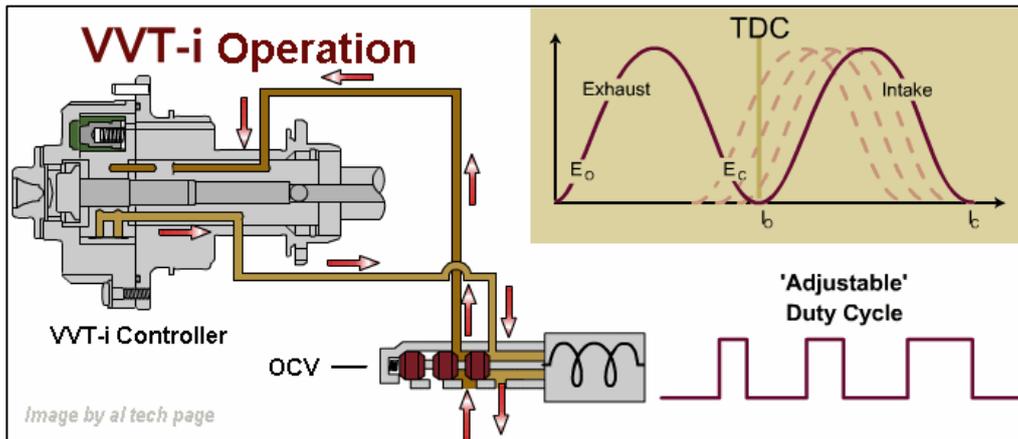
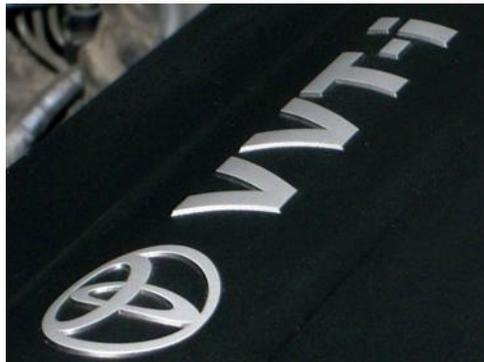
Note. The engine control module (ECM) optimizes the valve timing using the VVT system to control the intake valve camshaft. The VVT system includes the ECM, the oil control valve (OCV) and the VVT controller (actuator).

The ECM sends “duty-cycle” control signals to the OCV. This electrical control signal, applied to the OCV, regulates the oil pressure supplied to the VVT controller (actuator).

The ECM compares the target valve timing with the actual valve timing calculated by using the signals from both the VVT sensor and the crankshaft position sensor. If a difference occurs between them, the ECM interprets it as a malfunction and sets a DTC.
