Repair Manual Supplement: Vehicle Pulling to One Side

Service Category Steering

Section Steering Gear/Linkage

TSIB SUPERSESSION NOTICE

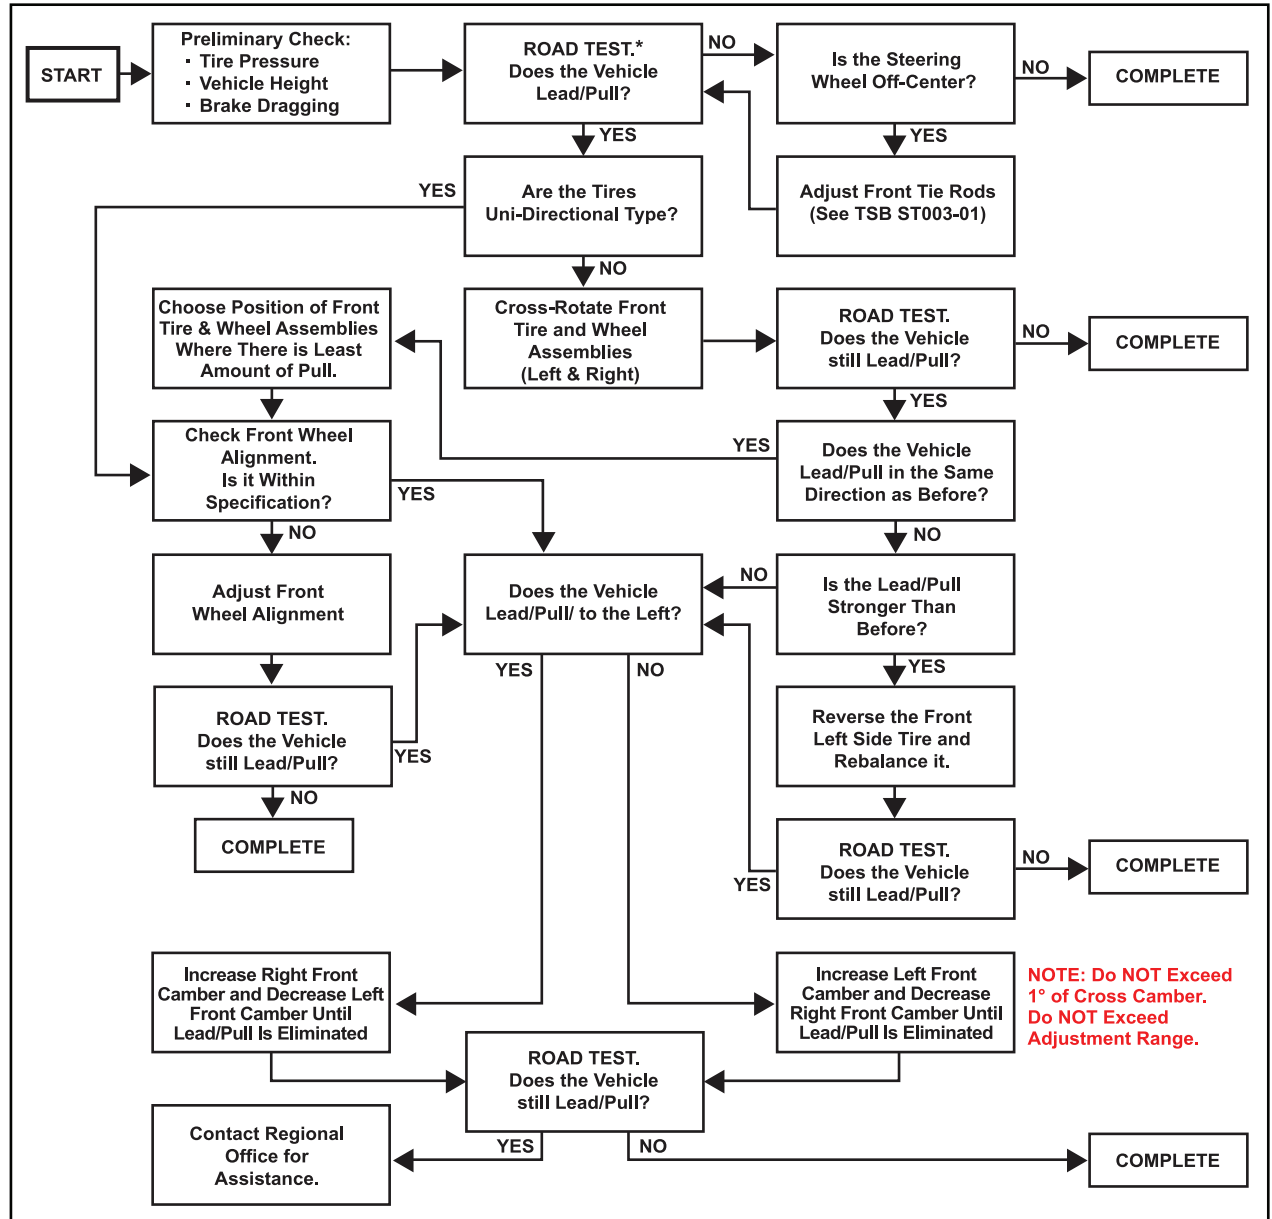
Figure 5.

Repair Procedure Flow Chart

NOTE: Do NOT Exceed 1° of Cross Camber. Do NOT Exceed Adjustment Range.

* Select a flat road where the vehicle can be driven in a straight line for 109 yards (100 meters) at a constant speed of 35 mph (56 km/h). Please confirm safety and set the steering wheel to its straight position. Drive the vehicle in a straight line for 109 yards (100 meters) at a constant speed of 35 mph (56 km/h) without exerting steering effort on the steering wheel.
