To: All Toyota Dealer Principals, Service Managers, Parts Managers

Subject: Safety Recall – A0B
Certain 2010 Model Year Prius Vehicles
ABS Actuator ECU Update

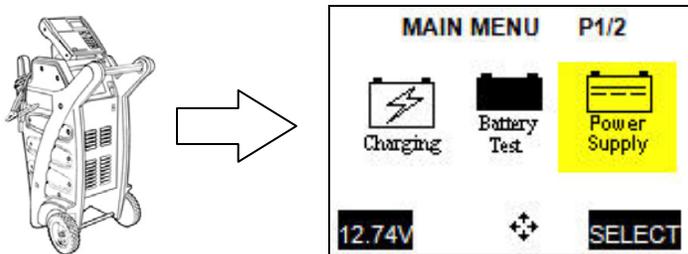
- a) Connect the GR8 Battery Diagnostic Station to the vehicle and turn it ON, then select Power Supply Mode as shown below.

- The GR8 Battery Diagnostic Station **MUST** be used in Power Supply Mode to maintain battery voltage at 13.5 volts while flash reprogramming the vehicle.
- For details on how to use the GR8 Battery Diagnostic Station, refer to the GR8 Instruction Manual located on TIS, *Diagnostics – Battery*.
- If the GR8 Battery Diagnostic Station is unavailable, the PSC Power Supply Charger / Maintainer (MTRPSC550SKT) may be used.

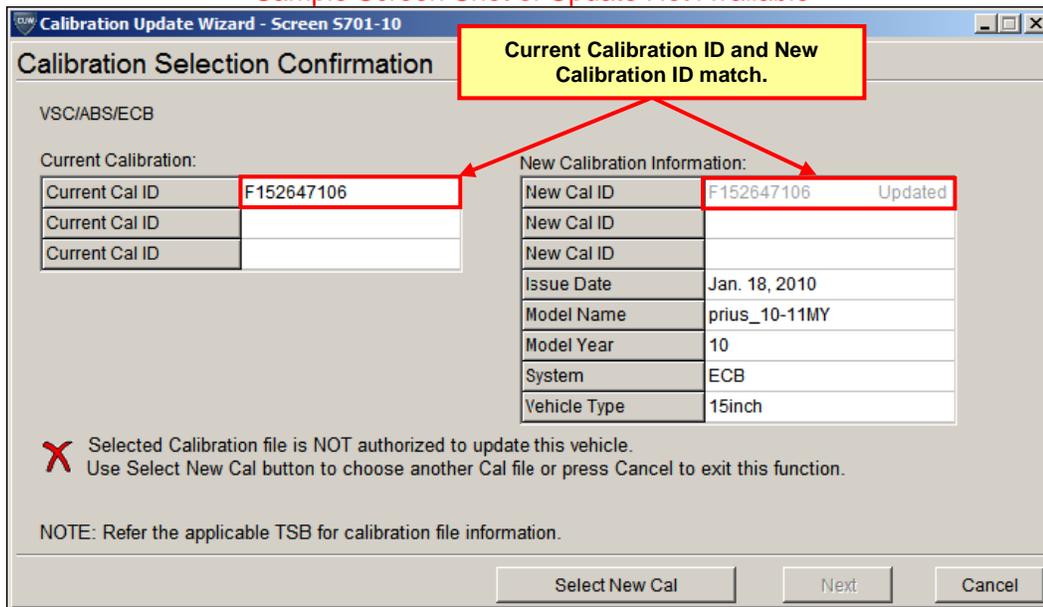
Sample Screen Shot of Update Not Available

7. If the Current Calibration ID and the New Calibration ID match the update has already been performed. Proceed with filing an Inspection Claim.
